## What happened?

During winter 2016/17, numerous community complaints were received of rotten-egg gas-like odors emanating from the western golf course lakes and waterways.

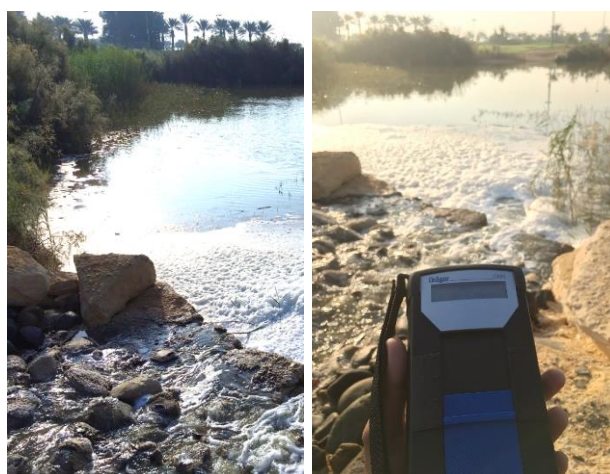
Still wind conditions and cool mornings combined to exacerbate the problem further. The heavy hydrogen sulfide gas accumulated overnight at ground level and was not dispersing until later in the morning when solar radiation and winds picked up.

Significant hydrogen sulfide gas detected at the lake

Environment Division of HSE recommended rapid oxygenation of the water column using an environmentally benign chemical that breaks down into oxygen and water. Following this activity the hydrogen sulfide odor was eliminated almost immediately.

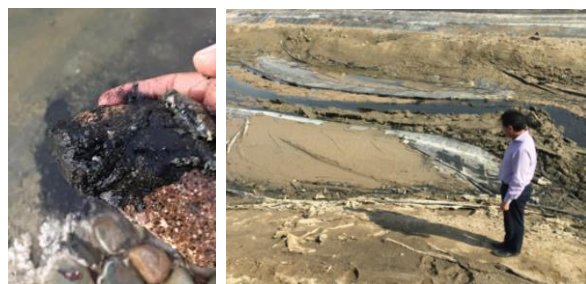
1. Historical planting of the deciduous Buttonwood tree (*Conocarpus erectus*) in the vicinity of the lake. The foliage dropped over the years had accumulated and resulted in anoxic 'peat-like' sedimentary layer;
2. Water recirculation pump breaking down approximately 6 weeks prior to the incident and being not quickly repairable, resulting in lake water column stratification and anoxia; and
3. Low winter rates of thermal water convection within the saline lake further promoting anoxic conditions.

Organic anoxic sediments in the lake system

1. Partial removal of the anoxic sedimentary layer from shallow lakes and waterways. As the Buttonwood trees had previously been removed due to their invasive root systems, the remaining anoxic source required removal; and
2. Water recirculation was re-instated with improved water quality monitoring and pump maintenance.

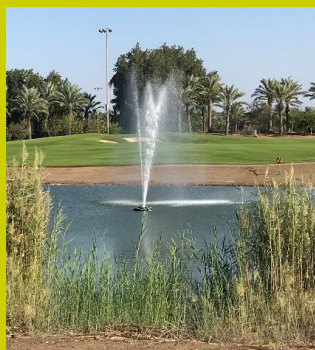
Water recirculation/oxygenation system in operation
