Isolation Valve Incidents

Purpose of the safety bulletin: To inform the research community about recent incidents involving gas lines leaking from behind wall panels within research spaces.

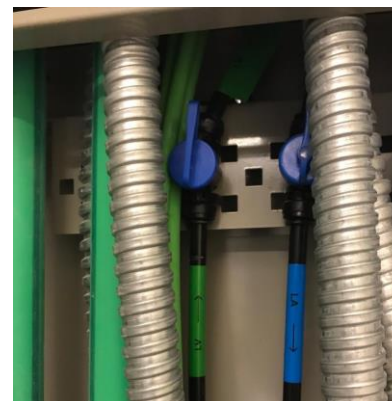
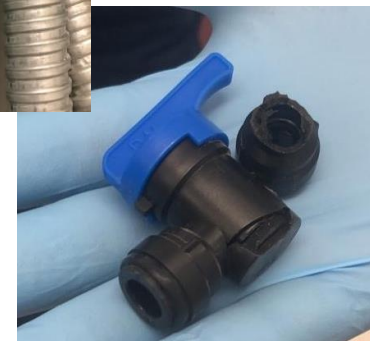
Over the months there have been reports mentioning “hissing” or “wheezing” noises coming from gas lines behind the laboratory casework panels. Upon investigation with Campus and Technology Park Services, all of the reported incidents involved a valve that malfunctioned which caused the noises and leaking.

The plastic isolation valve adaptors are corroding/degrading over time due to excessive amounts of volatile solvents in the vacuum lines. Solvent traps must be kept very cold in order to condense volatile vapors. Maintain solvent traps to maintain the in-house vacuum! The valves are also breaking due to age and general usage in the gas and air lines. Campus and Technology Park Services are replacing these valves as each situation is reported.

If you hear any noises coming from behind the wall panels or from any other areas from the laboratory, please contact the fchelpdesk by dialing 959 from the office phone or 808-0959 from your mobile.
