Lessons Learnt from University of Hawaii incident March 2016

Purpose of the safety bulletin: To inform the research community about an incident that happened in University of Hawaii and to highlight the importance of risk assessments and safety requirements.

Based on the Report to the University of Hawaii at Manoa on the Hydrogen/Oxygen Explosion of March 16, 2016

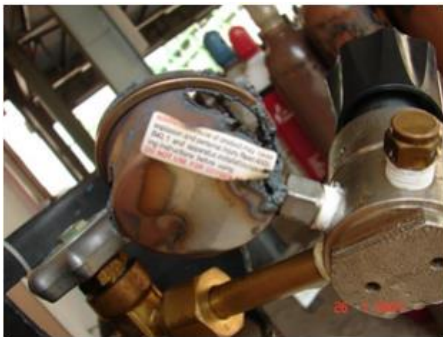
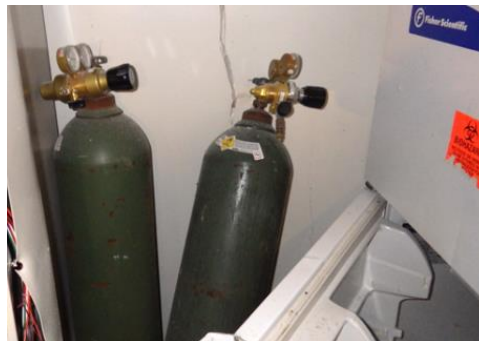
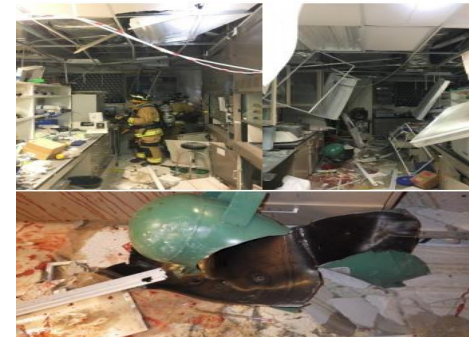
On Wednesday 16th March postdoctoral researcher Thea Ekins-Coward was working on combining hydrogen, carbon dioxide, and oxygen gases from high-pressure cylinders into a lower pressure container. The mixture was to be used as a feedstock to grow bacteria to produce bioplastics and biofuels inside of a low-pressure tank. The investigation report from Honolulu Fire Department investigation EHRS 2016 Safety Alert (KB) UPDATED 8/4/2016 concluded that an electronic gauge, which was used to measure the pressure inside the gas-mixing vessel, created a spark when Dr. Ekins-Coward pressed the “off” button. The spark ignited the gas inside the tank, triggering the explosion. The electronic gauge was not designed to be used in a system containing a flammable gases mixture. A mixture of 70% hydrogen, 25% oxygen, and 5% carbon dioxide was used in the experiment. The week before the incident, a similar set-up with a 3.8-L tank resulted in a “small internal explosion” when Ekins-Coward pressed the off button on the gauge. She also occasionally experienced static shocks when touching the tank, which was not grounded. She reported the shocks and possibly the small explosion to PI, who told her not to worry about it.

- **Lab Safety Inspections:** Lack of rigorous safety inspections.
- **Chemical hygiene & hazardous waste plan:** No evidence of updates.
- **Lab Specific SOPs & Training Program:** Lack of lab specific SOPs and training over and above general safety requirements.
- **PPE:** Researchers were not wearing appropriate PPE. Furthermore, despite using a highly flammable gas and pure oxygen, wearing flame resistant laboratory coats was not the norm.
- **Gas Cylinder Use:**
 - Improper gas cylinder restraint and storage, unlabeled gas lines and leaking aged regulators.
 - The gas storage tank contained an O₂ enriched mixture and was not properly cleaned as combustible oil was found on the threaded fittings.
 - Use of plastic tubing such as polyethylene (PE) is not safe for hydrogen gas as it can diffuse through the wall.

- Never underestimate the hazards associated with an experiment.
- Gas cylinders should be restrained by chains and secured.
- Clear and detailed standard operating procedures and lab specific training should be provided to all lab users.
- Regular discussions about Near Miss and Lessons Learned events should be conducted to remind lab users of the risk involved when working with highly hazardous substances or processes.
- Mixing a flammable gas (hydrogen, methane, etc.) with an oxidizer gas (oxygen, chlorine) is an inherently unsafe activity. In the worst-case scenario it can result in a reaction leading to a detonation which can be fatal and cause significant damage.
