## What happened?

During winter 2016/17, numerous community complaints were received of rotten-egg gas-like odors emanating from the western golf course lakes and waterways.

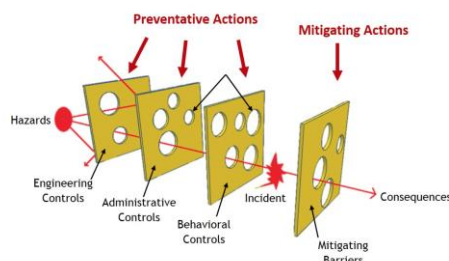
The Swiss-cheese model of incident causation illustrates that, although many layers of defense lie between hazards and consequence, there are flaws in each layer that, if aligned, can allow the consequence to occur. Key events that resulted in this particular odor incident were:

1. Historical planting of the deciduous Buttonwood tree (*Conocarpus erectus*) in the vicinity of the lake. The foliage dropped over the years had accumulated and resulted in anoxic 'peat-like' sedimentary layer;
2. Water recirculation pump breaking down approximately 6 weeks prior to the incident and being not quickly repairable, resulting in lake water column stratification and anoxia; and
3. Low winter rates of thermal water convection within the saline lake further promoting anoxic conditions.

Swiss-cheese model of incident causation
