## Risk Anticipation and Risk Mitigation

**Purpose of the safety bulletin:** To inform the research community about an incident that happened in KAUST, which could have been prevented through a risk assessment and following safe work practices.

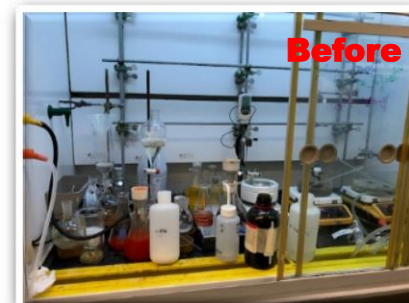
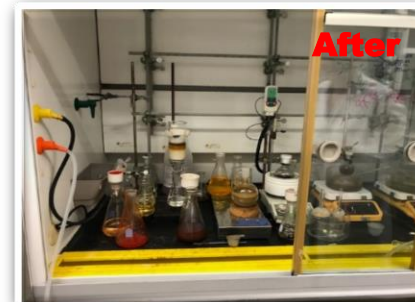
On Thursday May 25th 2017 a lab user was conducting an extraction procedure using Dichloromethane, Sodium Bicarbonate, and a reaction mixture. While the lab user was releasing CO<sub>2</sub>, an unexpected amount of CO<sub>2</sub> was released from the reaction mixture inside the separating funnel, causing the separating funnel stopper to “pop.” As a result, a chemical splash occurred. The lab user immediately followed the correct emergency procedures (removing contaminated clothing, flushing eyes and washing skin), and informed the LSR of the incident. No personal injury occurred.

- Familiarity with the procedure led to overconfidence in conducting the experiment. Therefore there was a failure to assess the potential risk and follow safe work practices.
- Poor housekeeping inside the fume hood prevented the lab user from using it.
- Because the procedure was conducted outside of the fume hood, there was no protection against a possible chemical splash.
- There was no SOP available for the safe use of separating funnels.

- Never underestimate the potential hazards associated with an experiment.
- Determine the potential hazards and appropriate safety precautions before starting an experiment.
- Avoid becoming too familiar with procedures. Ask yourself questions such as “What can go wrong?” and “How can it be prevented?”
- Fume hoods are not storage cabinets. Fume hoods must be maintained and used in a clutter-free state.
